3.8 Magnitude Earthquake in Sylhet Area, Bangladesh - A Case Study of School Building Damage

Mohammad Feruj Alam^{1*}, Md. Azahar Hossain¹, Minhazul Abedin Shakik¹, Faruk Hossain¹ and Razi Uddin Khan²

¹Geological Survey of Bangladesh, Segunbagicha, Dhaka, Bangladesh

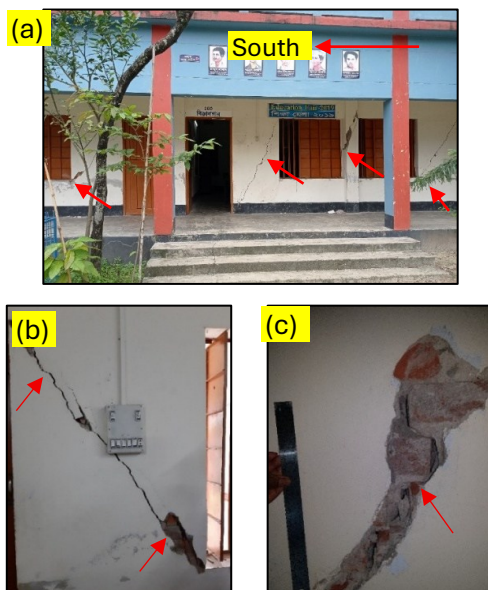
The SCC area lies on the most seismically active zone in Bangladesh and PGA value is 0.36 g (BNBC, 2020). The two-story Badar Uddin Ahmed Kamran building of Raja GC High School was damaged due to the 7 June 2021 event, a minor and shallow earthquake. This building was constructed in 2006 and horizontally and vertically extended on 2018 by the Education Engineering Department. A series of N-S diagonal cracks were observed on the outside and inside of the pillar and wall (shown by the red arrow in Figure 1a). Some diagonal cracks created gaps or apertures where light from outside could be seen through the wall. Plaster of both side of the cracks were fall (shown by red arrows in Figure 1b and c). The septic tank with the pipelines were settled at different rates due to this earthquake and maximum 10 inches were settled at the S-W corner of the septic tank. A pipeline of the septic tank also was settled at a different rate. According to EMS-98 (Grünthal 1998), building damages are classified as Grade 2 (moderate damage class/category).

Groundwater level was 1.5 m at the damaged building site during fieldwork. The saturated sand layer may have the potential for liquefaction, and soft filling materials with different thickness were triggered to differential settlement of the damaged building. Quakes of magnitudes between 3 and 4 occur frequently in all over the world, as well as in Bangladesh, but there are no reports on significant damage like in the case of the studied school building damage. According to the SCC development plan, by 2030, the city area is expected to be 85 sq. km. If low-lying areas, ponds, and marshy land would be filled for the construction ground, then the building could be exposed to damage by a minor earthquake.

Figure 1, A series of diagonal cracks at the outside view (a) and close inside views of diagonal cracks (b) and (c) of the damaged building (Badar Uddin Ahmed Kamran building of Raja GC high school), Bandar Bazar, Sylhet.

- ❖ Landfill sites without proper ground compaction or improvement should be avoided for this type of building.
- ❖ Clay materials should be avoided to select as a filling material for construction sites.
- ❖ Landfilling and ground improvement activities should be monitored by civil engineers or engineering geologists.
- ❖ Landfill sites should be totally avoided for the construction of school buildings and high-rise buildings.
- ❖ The damaged school building should be used until it is retrofitted.
- ❖ Building codes should be followed for building construction.
