3.8 Magnitude Earthquake in Sylhet area, Bangladesh - A Case Study of School Building Damage

Mohammad Feruj Alam^{1*}, Md. Azahar Hossain¹, Minhazul Abedin Shakik¹, Faruk Hossain¹ and Razi Uddin Khan²

¹Geological Survey of Bangladesh

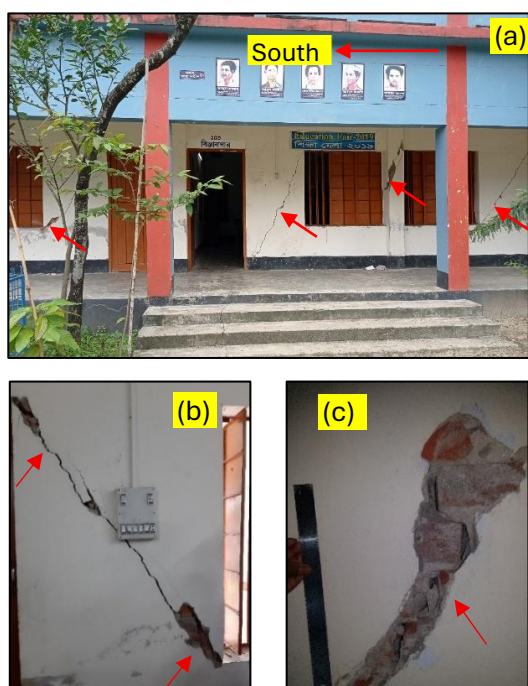
The SCC area lies on the most seismically active zone in Bangladesh and PGA value is 0.36 g (BNBC, 2020). The two-story Badar Uddin Ahmed Kamran building of Raja GC High School was damaged due to the 7 June 2021 event, a minor and shallow earthquake. This building was constructed in 2006 and horizontally and vertically extended on 2018 by the Education Engineering Department. A series of N-S diagonal cracks were observed on the outside and inside of the pillar and wall (shown by the red arrow in Figure 1a). Some diagonal cracks created gaps or apertures where light from outside could be seen through the wall. Plaster of both side of the cracks were fall (shown by red arrows in Figure 1b and c). The septic tank with the pipelines were settled at different rates due to this earthquake and maximum 10 inches were settled at the S-W corner of the septic tank. A pipeline of the septic tank also was settled at a different rate. According to EMS-98 (Grünthal 1998), building damages are classified as Grade 2 (moderate damage class/category).

Groundwater level was 1.5 m at the damaged building site during fieldwork. The saturated sand layer may have the potential for liquefaction, and soft filling materials with different thickness were triggered to differential settlement of the damaged building. Quakes of magnitudes between 3 and 4 occur frequently in all over the world, as well as in Bangladesh, but there are no reports on significant damage like in the case of the studied school building damage. According to the SCC development plan, by 2030, the city area is expected to be 85 sq. km. If low-lying areas, ponds, and marshy land would be filled for the construction ground, then the building could be exposed to damage by a minor earthquake.

Figure 1, A series of diagonal cracks at the outside view (a) and close inside views of diagonal cracks (b) and (c) of the damaged building (Badar Uddin Ahmed Kamran Building of Raja GC high school), Bandar Bazar, Sylhet.

- ❖ Landfill sites without proper ground compaction or improvement should be avoided for this type of building.
- ❖ Clay materials should be avoided to select as a filling material for construction sites.
- ❖ Landfilling and ground improvement activities should be monitored by civil engineers or engineering geologists.
- ❖ Landfill sites should be totally avoided for the construction of school buildings and high-rise buildings.
- ❖ The damaged school building should be used until it is retrofitted.
- ❖ Building codes should be followed for building construction.
