Geotechnical Challenges and Adaptive Solutions in the Nagdhunga Tunnel Construction Project

Abstract: The Nagdhunga Tunnel Construction Project in Nepal encountered a range of substantial geotechnical challenges, primarily due to the Himalayan region's complex and unpredictable geological conditions. Constructed using the New Austrian Tunneling Method (NATM), the project required significant adaptations to contend with collapses and sidewall deformation observed during excavation. Nepal's geology, dominated by ongoing tectonic activity thrust faults, and high-pressure metamorphic rocks, posing risks specific to accretionary prism formed by plate collision. This experience highlights critical considerations for future underground infrastructure projects in Nepal and similar geologically active zones, particularly concerning geological complexity and logistical constraints related to material procurement.

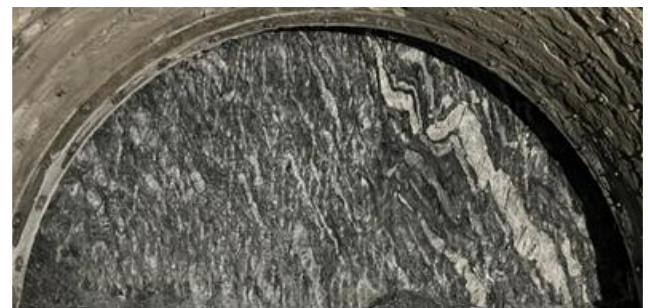
Excavation revealed relatively, at the boundary between the Sopyang formation and the Tistung formation on the west side, thrust faults with a north-south strike and a westward dip repeatedly appeared. Moreover, in the central section of the tunnel, the geology was primarily composed of black schist to phyllite interbedded, and fracture zones fragmented into flaky pieces a few millimeters wide were observed. The schistosity plane

of the black schist was concentrated with mica, exhibiting a glossy dark black color and scaly cleavage. The face condition where the fracture zone was distributed is shown in Figure 2 and the geological map reviewed based on excavation is shown in Figure 3.

Figure 2, Fractured layer at 1+951.

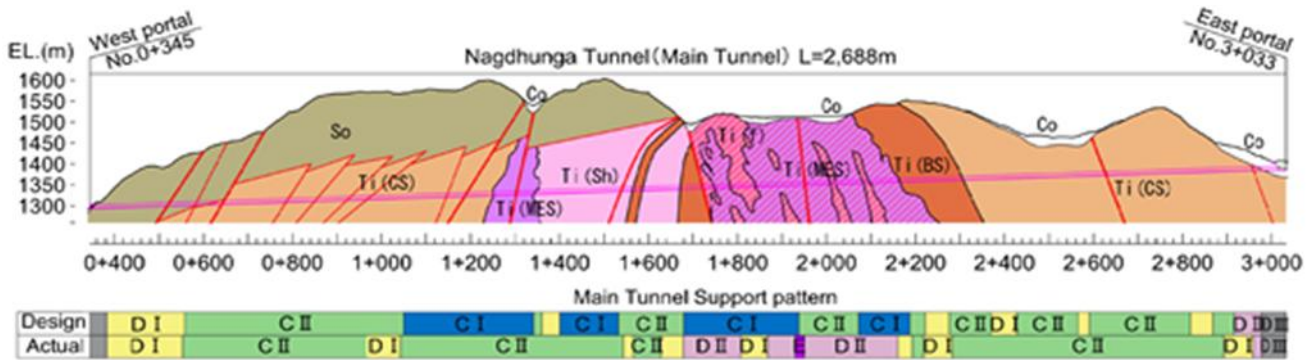
Figure 3, Geological profile (Review based on excavation).

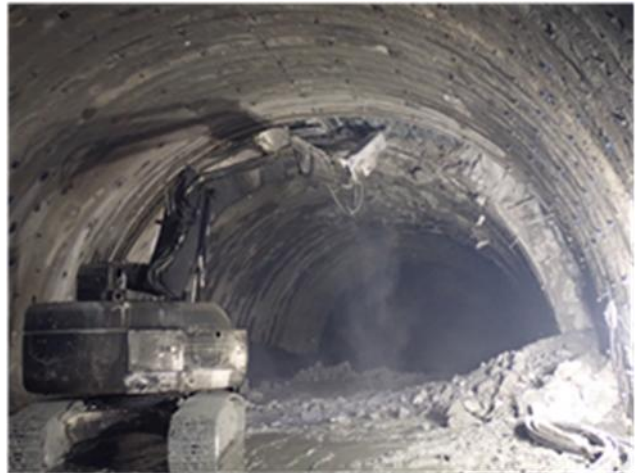
At station No. 1+951, a collapse occurred in the crown to the right shoulder. The collapse recurred intermittently, and the face was buried by the collapsed soil. Immediately after the collapse, the shotcrete on the crown spalled off, and the heads of the sidewall rock bolts shot out horizontally with a snapping sound. Furthermore, the steel ribs installed at 50 cm intervals were destroyed by buckling and rupture at the crown. Given this situation, it was deemed dangerous to attempt collapse countermeasures at the face, so it was decided to begin the re-installation of the destroyed supports from 60 m behind.

Figure 4 Re-excavation due to increased displacement.

Since a significantly vulnerable fault clay was distributed in this section, there was a concern that the support rigidity might be insufficient even if re-excavation was performed with the DII pattern. Therefore, a FEM analysis was conducted based on the results of the convergence measurements to calculate the stress acting on the support members. The results showed that the DII pattern lacked sufficient load-bearing capacity, so the E pattern (H-200 steel ribs, shotcrete thickness $t=250$ mm) was adopted. The condition of the re-excavation is shown in Figure 4.

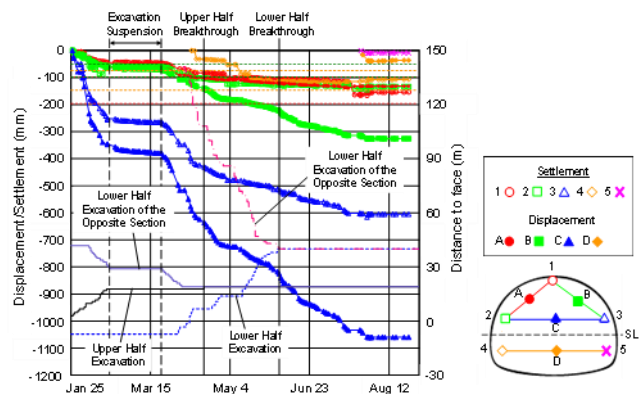
Nevertheless, even displacements exceeding 1 m were confirmed to converge upon the completion of all ground excavation, including invert excavation and re-excavation after the breakthrough. This ground behavior is considered a particularly important characteristic for examining the deformation mechanism during tunnel excavation in Nepal. The measurement results at station No. 1+948, where the E pattern using H-200 was applied, are shown in Figure 5.

Figure 5, Example of convergence measurement.
