A Complex Landslide in Ichinose Area Triggered by the 2024 Noto Peninsula Earthquake in Japan

Gonghui Wang^{1*}, Jiangkun He², Gen Furuya³, Issei Doi¹, Koichi Hhayashi¹, and Yasuhiko OKADA⁴

¹Disaster Prevention Research Institute, Kyoto University, Japan

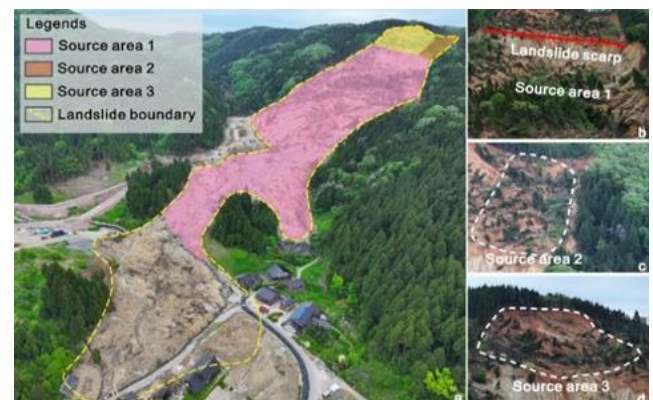
The lithology at the head of the Ichinose landslide is dominated by conglomerate, tuffaceous sandstone, and andesitic pyroclastic rocks, whereas the middle to lower portions consists mainly of alternating sandstone, mudstone, and conglomerate. Field investigations suggest that the Ichinose landslide involved the movement of three distinct source areas, as schematically illustrated in Figure 1a. First, instability was triggered in Area 1 (Figure 1b), where the lower part of the slope fluidized, generating a debris flow approximately 6 m thick that traveled downslope and was deposited in residential areas about 600 m from the landslide toe. Second, the wedge-shaped Source Area 2 (Figure 1c) failed, and its mass was deposited at the

base of the main scarp. Finally, Source Area 3 (Figure 1d) failed, with part of the displaced material deposited in a lateral gully and the remainder deposited on the exposed sliding surface of Source Area 1. Notably, the fluidization of the toe in Area 1 greatly amplified the destructive impact of the event. This sequence of failures underscores the complex, multi-stage nature of the Ichinose landslide.

Figure 1, (a) Overview of Ichinose landslide; (b)–(d) Close-up Views of different locations of source area.

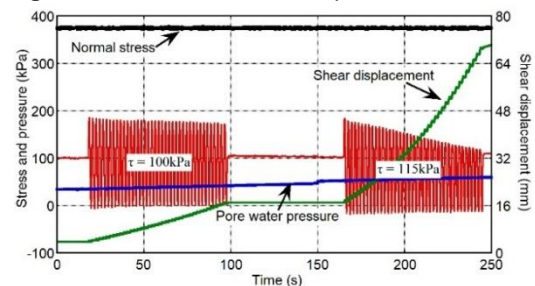
Representative test results are shown in Figures. 2–4. The test on S1 (clayey soil sampled from the sliding surface layer originated from Source Area 3) demonstrated that shear failure occurred only after prolonged cyclic loading, accompanied by a gradual increase in pore-water pressure (PWP), indicating a relatively low liquefaction potential. In contrast, S2 (sandy soil) exhibited shear failure within the same loading duration but with a rapid buildup of PWP, suggesting a higher liquefaction potential. The test on S3 (sandy soil) showed shear failure after a shorter loading duration, with a moderate increase in PWP, also indicating a relatively high liquefaction potential.

Figure 2, Undrained cyclic shear loading test on S1.

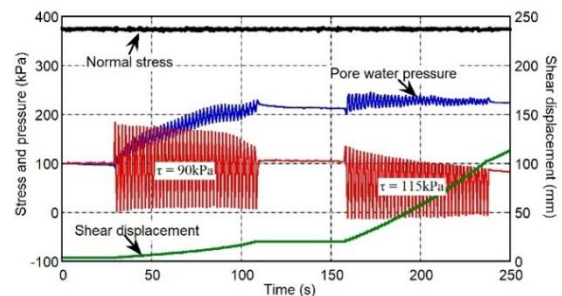
Figure 3, Undrained cyclic shear loading test on S2.

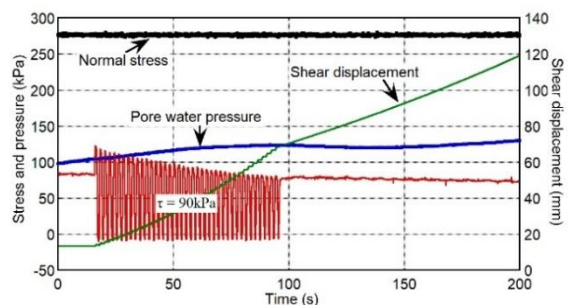
Figure 4, Undrained cyclic shear loading test on S3.

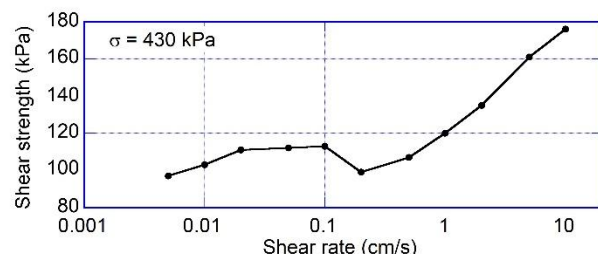
The test results for S1 indicate that the material from Source Area 3 has very low liquefaction potential. The residual shear strength of S1 also presents diverse shear rate-dependent behavior (Figure 5), showing that S1 is unlikely to fail solely under seismic loading. However, given the relatively steep slope of Source Area 3, failure of Source Area 2 could create a free face at its toe, potentially destabilizing the mass and inducing slides. This interpretation is consistent with field investigation findings. Comparison of the three test results further shows that S3 exhibits the lowest resistance to cyclic loading and is therefore most susceptible to liquefaction under seismic or other dynamic disturbances. This suggests that the toe area was the most likely to undergo liquefaction, which may explain the fluidized landsliding behavior observed in video recordings.

Figure 5, Residual shear strength of S1.
