# A Complex Landslide in Ichinose Area Triggered by the 2024 Noto Peninsula Earthquake in Japan

**Abstract:** During the 2024 Noto Peninsula Earthquake ( $M_w7.5$ ) in Japan, many landslides of different types and scales occurred, resulting in great damage to local properties and casualties. In this study, we introduce a large-scale landslide occurring in Ichinose area, Wajima City. This landslide originated from an old landslide, and the displaced landslide mass showed complex landsliding behavior. Through field geological and geophysical surveys and geotechnical examinations, the features of this landslide were detailed, and the possible initiation and movement mechanisms were examined. The main findings will be reported in this study.

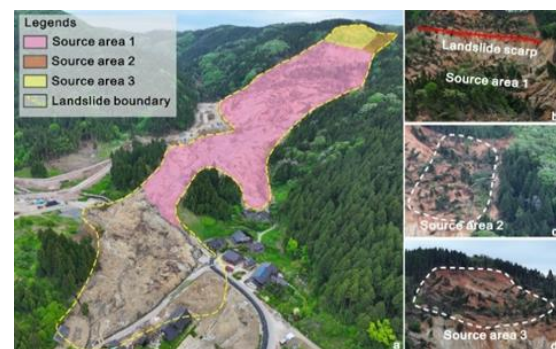
The lithology at the head of the Ichinose landslide is dominated by conglomerate, tuffaceous sandstone, and andesitic pyroclastic rocks, whereas the middle to lower portions consists mainly of alternating sandstone, mudstone, and conglomerate. Field investigations suggest that the Ichinose landslide involved the movement of three distinct source areas, as schematically illustrated in Figure 1a. First, instability was triggered in Area 1 (Figure 1b), where the lower part of the slope fluidized, generating a debris flow approximately 6 m thick that traveled downslope and was deposited in residential areas about 600 m from the landslide toe. Second, the wedge-shaped Source Area 2

(Figure 1c) failed, and its mass was deposited at the base of the main scarp. Finally, Source Area 3 (Figure 1d) failed, with part of the displaced material deposited in a lateral gully and the remainder deposited on the exposed sliding surface of Source Area 1. Notably, the fluidization of the toe in Area 1 greatly amplified the destructive impact of the event. This sequence of failures underscores the complex, multi-stage nature of the Ichinose landslide.

Figure 1, (a) Overview of Ichinose landslide; (b)–(d) Close-up Views of different locations of source area.

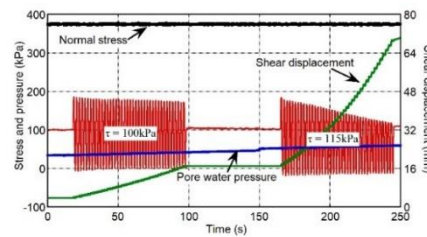
Representative test results are shown in Figures. 2–4. The test on S1 (clayey soil sampled from the sliding surface layer originated from Source Area 3) demonstrated that shear failure occurred only after prolonged cyclic loading, accompanied by a gradual increase in pore-water pressure (PWP), indicating a relatively low liquefaction potential. In contrast, S2 (sandy soil) exhibited shear failure within the same loading duration but with a rapid buildup of PWP, suggesting a higher liquefaction potential. The test on S3 (sandy soil) showed shear failure after a shorter loading duration, with a moderate increase in PWP, also indicating a relatively high liquefaction potential.

The test results for S1 indicate that the material from Source Area 3 has very low liquefaction potential. The residual shear strength of S1 also presents diverse shear rate-dependent behavior (Figure 5), showing that S1 is unlikely to fail solely under seismic loading. However, given the relatively steep slope of Source Area 3, failure of Source Area 2 could create a free face at its toe, potentially destabilizing the mass and inducing slides. This interpretation is consistent with field investigation findings. Comparison of the three test results further shows that S3 exhibits the lowest resistance to cyclic loading and is therefore most susceptible to liquefaction under seismic or other dynamic disturbances. This suggests that the toe area was the most likely to undergo liquefaction, which may explain the fluidized landsliding behavior observed in video recordings.

Figure 2, Undrained cyclic shear loading test on S1.

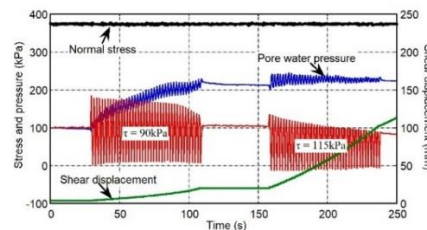
Figure 3, Undrained cyclic shear loading test on S2.

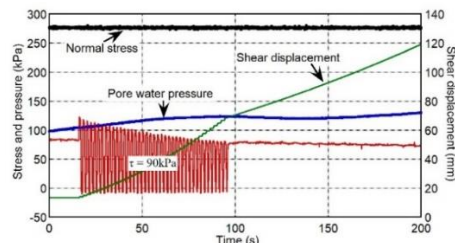
Figure 4, Undrained cyclic shear loading test on S3.

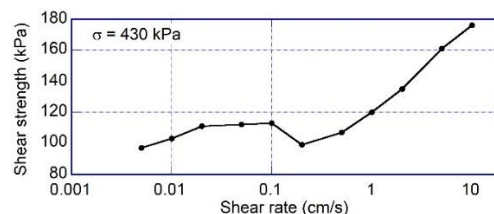
Figure 5, Residual shear strength of S1.
