# Engineering Geological Evaluation of the Krishna Bhir Landslide, Benighat Rorang, Dhading District, After the 2026 Rasuwa Flood

Samyog Khanal<sup>1\*</sup>

**Abstract:** The Krishna Bhir landslide, located along the Prithvi Highway in Dhading District, Nepal, represents a reactivated, complex slope failure that severed a critical national transportation corridor. This study presents field-based geological observations and structural assessment carried out around the landslide shortly after the 26 August 2026 Rasuwa flood. Results indicate that fluvial toe erosion by the Trishuli River, intensified by flood-induced sediment aggradation and subsequent channel migration, served as the principal triggering factor, removing basal confinement and destabilising the overlying slope mass. Multiple tension cracks were documented across the crown, flanks, and reactivated landslide body, with thicknesses of 2–5 m and separations of 15–35 cm, alongside uphill cracks of 25–30 cm separation and 1–2 m depth, confirming progressive retrogressive deformation. Structural evaluation of the existing retaining and gabion wall systems revealed cracking of 20–50 mm and downward displacement exceeding

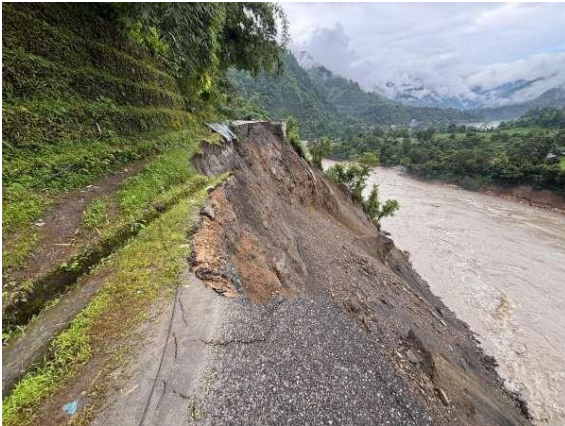
Field mapping shows the landslide mass is dominated by toppling failure, with steeply dipping (~70°) beds and north-facing joints (~30° in the slide mass) controlling the failure geometry. The Trishuli River progressively undercut the slope toe during the flood: elevated sediment influx raised the riverbed and altered channel

hydraulics, and bank deposition forced a lateral shift of the current toward the slope base. This removed the natural buttress and basal shear resistance, triggering collapse of the highway and slope, and provides a clear example of a toe-erosion-controlled failure (*Figure 1*).

*Figure 1, Toe erosion and collapse of the Prithvi Highway above the Trishuli River at Krishna Bhir.*

The Krishna Bhir landslide is a reactivated, complex failure driven by fluvial toe erosion, weak lithology and anthropogenic slope disturbance. Undercutting by the Trishuli River removed critical toe support, while crown, flank and uphill tension cracks confirm ongoing retrogressive movement, and deformation of the retaining and gabion structures shows that existing mitigation has been exceeded. Highly weathered slate, black slate and carbonate–quartz assemblages further weaken the rock mass, and the new road cut above the crown aggravates instability. Priority measures include surface and subsurface drainage, reducing the cut-slope angle below 40° in weathered slate while retaining steeper angles only in competent rock, benching with backslope drains, selective removal of loose material, and toe protection along the Trishuli River, supported by continuous monitoring and early-warning instrumentation.

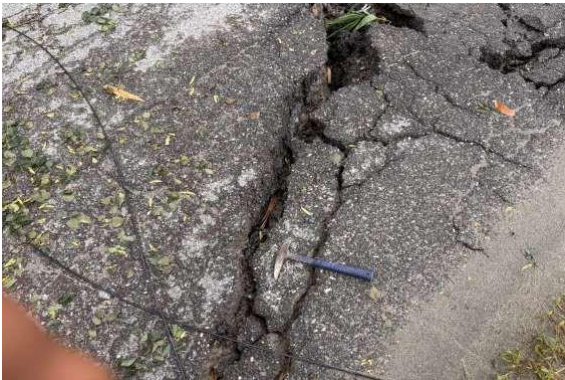
Multiple tension cracks confirm active retrogressive deformation. Within the road and main scarp, cracks indicate a disturbed zone 2–5 m thick with apertures of 15–35 cm (*Figure 2*), pointing to a relatively deep-seated failure rather than superficial cracking. On the uphill side, above the old gabion wall within the pre-existing landslide mass, cracks of 25–30 cm aperture and 1–2 m depth were recorded; similar but less intense cracking had been documented here by the Department of Mines and Geology in 2024, implying that road-cut excavation has since removed lateral confinement while toe failure has propagated upslope.

*Figure 2, Tension crack in the road pavement at Krishna Bhir, showing lateral displacement of the road surface.*
