# Integrated Engineering Geological and Geotechnical Assessment, Slope Stability Analysis at the Building on Landslide, Nagarkot, Nepal

**Abstract:** Rainfall-induced slope instability at a hotel construction site, Nagarkot, was investigated following a landslide triggered by approximately 16 hours of continuous heavy rainfall on July 6, 2024. The study integrates engineering-geological mapping, topographic surveying, geotechnical investigation, infiltration testing, laboratory analysis, borehole data, and limit-equilibrium slope-stability analysis to characterize the unstable slope and assess mitigation measures. The investigation covered approximately 11,000 m<sup>2</sup> and included total-station surveying, field-density and portable DCPT testing, infiltration measurements, geological mapping, grain-size analysis, moisture content, specific gravity, Atterberg limits, and direct-shear testing. The slope comprises gneissic bedrock overlain by variable colluvium and silty soil, with springs, erosional gullies, cracks, a roadside canal, and damaged retaining structures contributing to instability. Laboratory results indicate moisture contents of 13.37–56.97%, specific gravity of 2

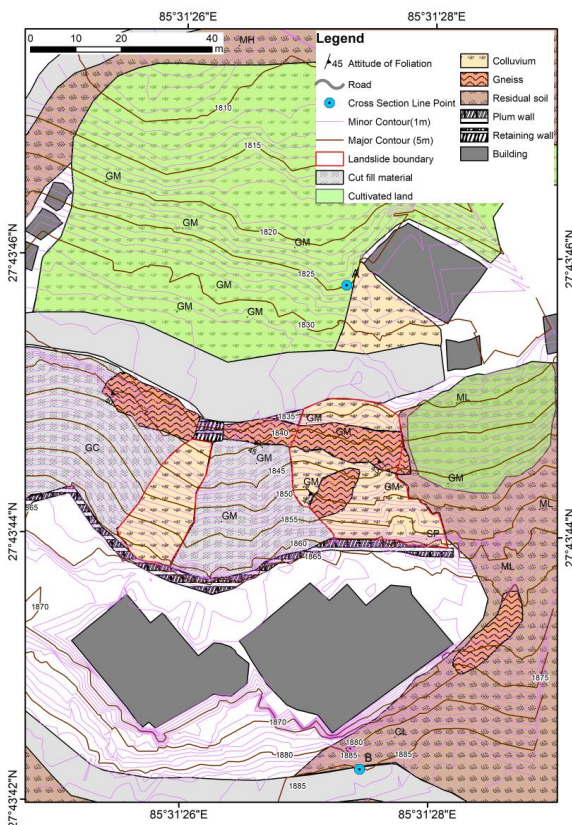
Engineering-geological mapping indicates that the unstable slope consists of gneiss bedrock (DMG, 2020) with a variable mantle of colluvium and silty to sandy soil. Silty gravel and gravelly sand are common, with clayey silt and poorly graded sand also present. The slope contains several erosional gullies and localized cracks, particularly toward the eastern and canal areas. These features indicate concentrated runoff, local saturation and zones of reduced ground integrity. The measured average infiltration rate of 0.0002 cm/s demonstrates that infiltration and drainage conditions require explicit consideration in stabilization design.

Figure 2, Site lithological map showing the distribution of geological materials.

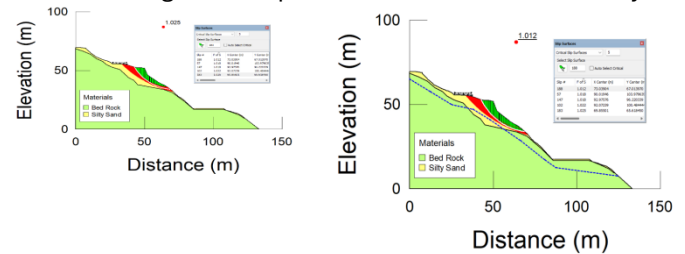
For the critical section at CH 0+040, the stability model considers a 90-mm grout-hole diameter, 32-mm reinforcement, 24-m reinforcement length, and 250-kPa bond strength. The overburden is characterized by

cohesion of 6 kPa, a friction angle of 26°, and unit weight of 16 kN/m<sup>3</sup>. Hard rock parameters include a unit weight of 26 kN/m<sup>3</sup>,  $M_i = 28$ ,  $GSI = 37$ , disturbance factor of 1, and UCS of 32 MPa.

Unmitigated analysis yields FOS values of 1.025 under dry conditions, 1.012 under probable groundwater conditions, and 0.472 under seismic loading, demonstrating inadequate and critical stability.

Figure 3, Reported global stability analyses for (a) dry and (b) probable groundwater conditions.

The reported Morgenstern–Price analysis gives FOS values of 1.025 in dry conditions, 1.012 with the probable water surface and 0.472 for the seismic condition, demonstrating inadequate stability in the existing state. The proposed combination of reinforcement/nailing and reinforced soil wall increases the modeled FOS to approximately 1.9. Effective surface and subsurface drainage, erosion control, construction quality control and long-term monitoring are recommended as integral components of the stabilization scheme. Particular attention should be given to changes in groundwater and crack development during the monsoon period.
