Response of JSEG (Japan Society of Engineering Geology) to the Noto Peninsula Earthquake in January 2024

Abstract: For the Noto Peninsula earthquake of 2024, JSEG formed a survey team of 119 members and conducted a year-long survey and research. As a result, it was clarified that topographical and geological characteristics of the Noto Peninsula and the surrounding area were largely responsible for the disaster caused by the earthquake. The results of the study were compiled into 43 reports, and a public meeting was held.

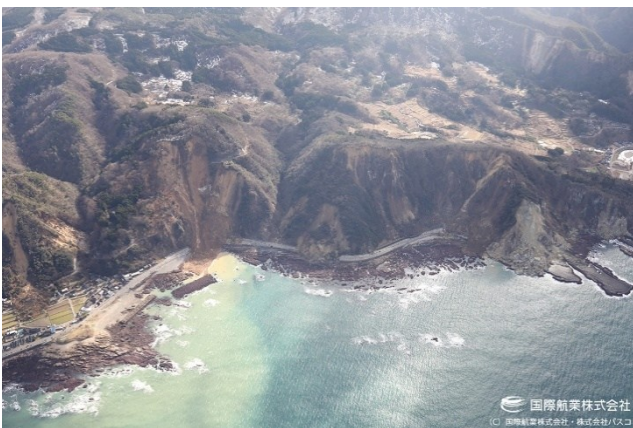
Figure 1, Landslide area on the northern coast of Noto Peninsula (January 2, 2024: Photo by Kokusai Kogyo).

In the Noto Peninsula, numerous slope failures and landslides occurred because of the earthquake. Especially in the cities of Suzu and Wajima at the northern end of the peninsula, there were thousands of large and small slope failures and landslides. The earthquake caused roads to be cut off and many villages to be isolated. Some villages were buried by collapsed debris. These slope failures and landslides are considered to have been largely caused by the unique topography, and geology of the Noto Peninsula.

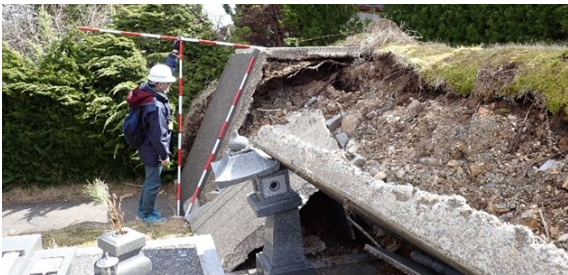
In Wakayama-Cho, Suzu City, in the northern part of the Noto Peninsula, surface displacements of up to 2 m in height occurred along the lowlands of the Wakayama River (Figure 2). It is still under debate whether this displacement was caused by faulting, geological structure, or related to landslide activity.

Figure 2, Surface displacements along Wakayama River.

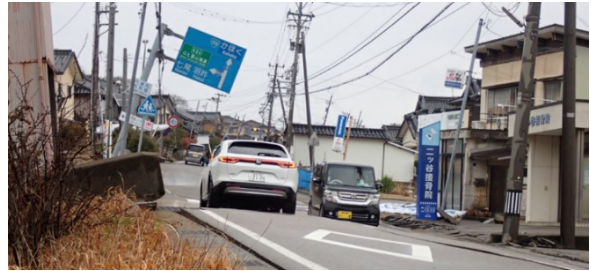
Peninsula, but there were also areas more than 100 km away from the epicenter that were severely damaged by liquefaction. In Kahoku City and Uchinada Town, Ishikawa Prefecture, and Niigata City, Niigata Prefecture, significant liquefaction occurred in areas behind dunes that developed along the Japan Sea and were heavily cut and flattened for sand mining and later urbanized. In these areas, liquefaction caused the ground to be displaced horizontally by up to 2 m, and many open cracks and compressive uplifts occurred on roads and the ground (Figure 3).

Figure 3, Cracks and Compressive Uplifts caused by lateral flow due to liquefaction (Uchinada-Town).
