# Application of LTFGF and PLAAF for Topographic Characteristics and Activity Assessment: Case Studies of Wuhe and Tsaoing

**Abstract:** Taiwan's convergence of active tectonic plates, heavy rainfall, and fragile geology leads to frequent landslides and persistent slope instability, further aggravated by extreme climate events. To enhance landslide susceptibility assessment and support risk management, this study systematically evaluates 2,500 potential large-scale landslides identified by the Central Geological Survey and Mineral Management Center. The Landslide Topographic Feature Grading Form (LTFGF) was developed to score topographic indicators such as scarps, sliding mass, lateral boundaries, toe morphology, and erosion conditions, classifying 1,566 sites into Grades A–D. Thirty-five representative sites, including Wuhe and Tsaoing, were further assessed using the Potential Large-scale Landslide Activity Assessment Form (PLAAF), which integrates failure mechanism interpretation, adverse stability features, historical bare area ratios, and displacement ratios (d/L). Statistical analysis shows Grades A + B represent 7.7% of sites, with LTFGF and PLAAF scores exhibiting a strong

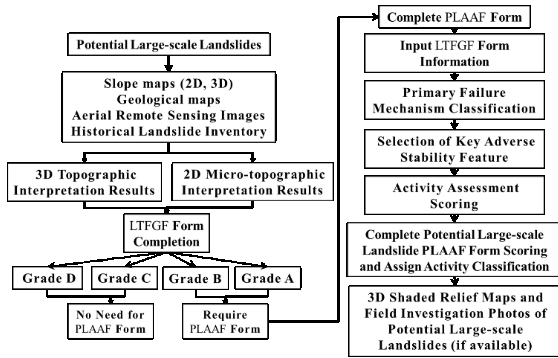
Figure 3, Flowchart of potential large-scale landslide grading and classification assessment procedure.

This study interprets landslide topographic features using LiDAR DEMs, contour maps, geological maps, and historical satellite imagery (Figure 3). The Landslide Topographic Feature Grading Form (LTFGF) scores scarps, sliding mass, boundaries, toe morphology, and erosion conditions, classifying 1,566 sites into Grades A–D (6, 114, 960, 486 sites). Thirty-five sites, including Wuhe and Tsaoing—were further assessed using the Potential Large-scale Landslide Activity Assessment

Form (PLAAF), which considers failure mechanisms (GSD, RS, PS, TC), adverse features, historical bare area ratios, and displacement ratios (d/L) (Chigira, 2009).

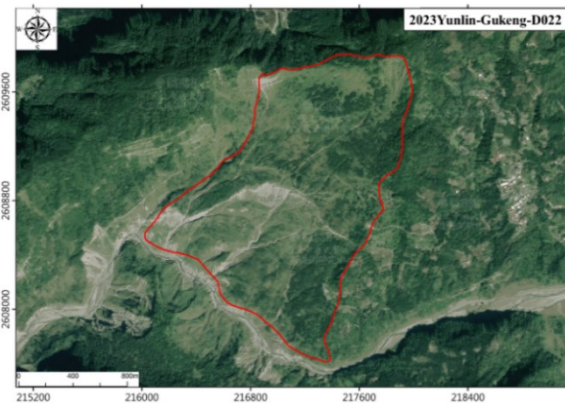
Figure 7, 2023 SPOT satellite imagery of Tsaoling.
