# Site Characterization and Rainfall Induced Landslide Risk Assessment at Balukhali Rohingya Refugee Camps of Ukhiya, Bangladesh

**Abstract:** This research is mainly focused on landslide hazards of the world's largest refugee camp of Ukhiya, Cox's Bazar Bangladesh. The whole area mainly small hillocks and hills of Ukhiya area are at great risk especially during monsoon. Several case studies result of recent slope failures is presented to understand the risk during monsoon in the camp area. From numerical seepage and stability modeling of slope at different locations of Ukhiya camps, it is established that Ukhiya hill slopes and the temporary shelters of Rohingyas are at great risk during monsoonal heavy rainfall for sustainable community-based living in the camp area. This study will ultimately help to manage hazards for sustainable hill management and settlement on hills. Based on the rainfall threshold (140 mm to 280 mm) line, warning system can be developed to save lives and properties of the camp inhabitants for further study.

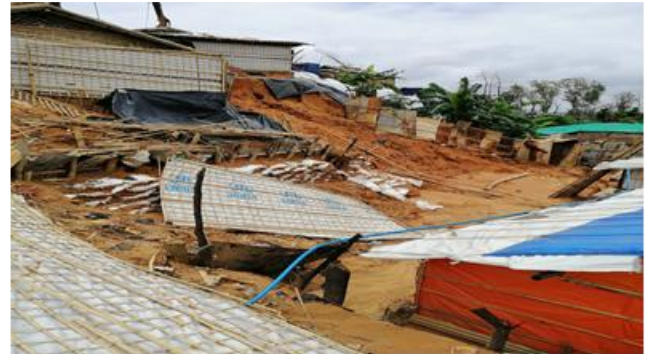
Figure 1, Landslide event in Balukhali Camp.
