# Exploring Joint Orientation Effects on the Failure of the Interbedded Rock Slope Using UDEC

**Abstract:** In Taiwan, the lives of residents and passersby in mountainous areas are frequently threatened by disasters such as rockfalls and landslides. These disaster-prone areas are mostly interbedded slopes composed of different lithologies, and differential erosion often occurs due to differences in their weathering resistance. Therefore, this study is based on geological survey results of an oblique slope with differential erosion in Miaoli County, Taiwan, to simulate the effects of varying joint orientation on slope failure and to explore whether specific failure patterns occur.

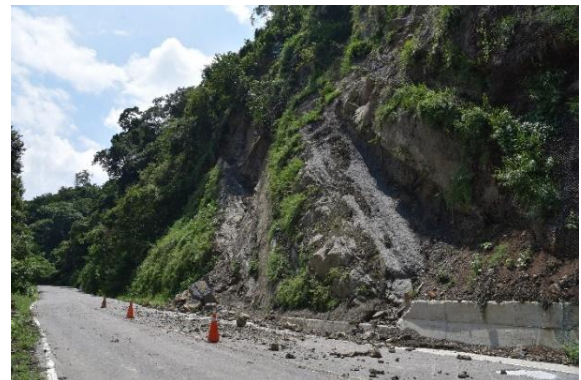
Figure 1, A collapse incident in 2022/08/29.
