Geotechnical Challenges and Adaptive Solutions in the Nagdhunga Tunnel Construction Project

Abstract: The Nagdhunga Tunnel Construction Project in Nepal encountered a range of substantial geotechnical challenges, primarily due to the Himalayan region's complex and unpredictable geological conditions. Constructed using the New Austrian Tunneling Method (NATM), the project required significant adaptations to contend with collapses and sidewall deformation observed during excavation. Nepal's geology, dominated by ongoing tectonic activity thrust faults, and high-pressure metamorphic rocks, posing risks specific to accretionary prism formed by plate collision. This experience highlights critical considerations for future underground infrastructure projects in Nepal and similar geologically active zones, particularly concerning geological complexity and logistical constraints related to material procurement.

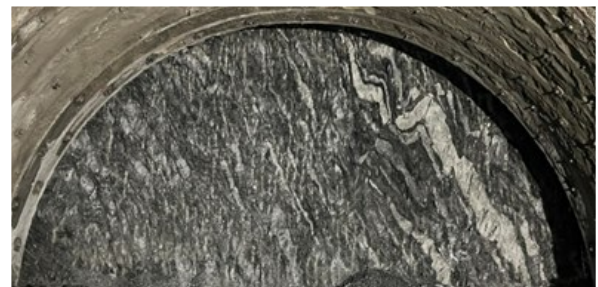
Figure 2, Fractured layer at 1+951.

fracture zones fragmented into flaky pieces a few millimeters wide were observed. The schistosity plane of the black schist was concentrated with mica, exhibiting a glossy dark black color and scaly cleavage. The face condition where the fracture zone was distributed is shown in Figure 2 and the geological map reviewed based on excavation is shown in Figure 3.

At station No. 1+951, a collapse occurred in the crown to the right shoulder. The collapse recurred intermittently, and the face was buried by the collapsed soil. Immediately after the collapse, the shotcrete on the crown spalled off, and the heads of the sidewall rock bolts shot out horizontally with a snapping sound. Furthermore, the steel ribs installed at 50 cm intervals were destroyed by buckling and rupture at the crown. Given this situation, it was deemed dangerous to attempt collapse countermeasures at the face, so it was decided to begin the re-installation of the destroyed supports from 60 m behind.

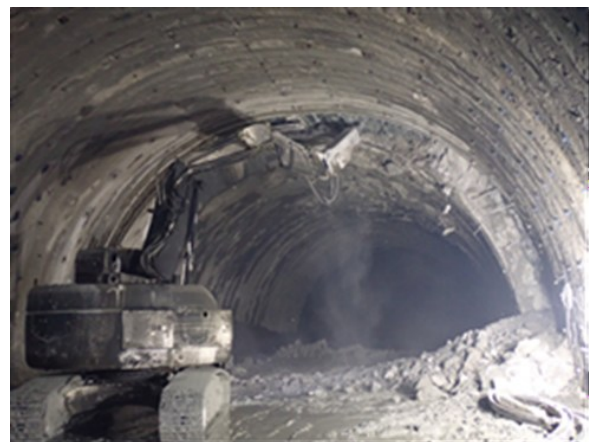
Figure 4 Re-excavation due to increased displacement.

Since a significantly vulnerable fault clay was distributed in this section, there was a concern that the support rigidity might be insufficient even if re-excavation was performed with the DII pattern. Therefore, a FEM analysis was conducted based on the results of the convergence measurements to calculate the stress acting on the support members. The results showed that the DII pattern lacked sufficient load-bearing capacity, so the E pattern (H-200 steel ribs, shotcrete thickness $t=250$ mm) was adopted. The condition of the re-excavation is shown in Figure 4.

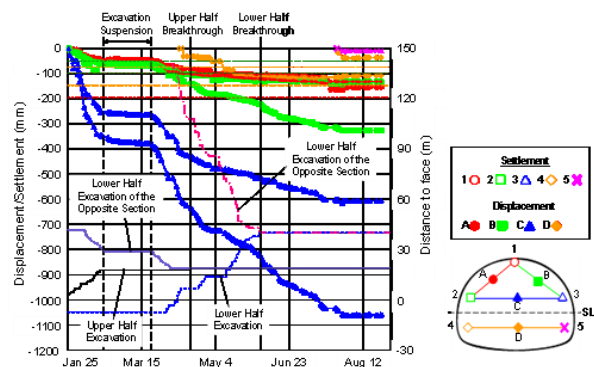
Figure 5, Example of convergence measurement.

Nevertheless, even displacements exceeding 1 m were confirmed to converge upon the completion of all ground excavation, including invert excavation and re-excavation after the breakthrough. This ground behavior is considered a particularly important characteristic for examining the deformation mechanism during tunnel excavation in Nepal. The measurement results at

station No. 1+948, where the E pattern using H-200 was applied, are shown in Figure 5.
