Geotechnical Investigation and Its Challenges in Landslide Dammed Valley of Nepal Himalaya: A Case History of Upper Tamakoshi Hydropower Project

Abstract: The natural damming of rivers by landslides is a prominent geomorphological phenomenon in the high, rugged mountains of the Nepal Himalaya. One such example is the wide valley of Lamabagar, which was formed by the landslide damming of the Tamakoshi River where the damsite of Upper Tamakoshi Hydropower Project (456MW) is constructed. Geotechnical investigations in such complex terrain are critical and typically involve multiple stages, including site investigation, soil and rock testing, modeling, empirical and mathematical analyses, field measurements, monitoring, and ultimately, the engineering design of structures. These steps are essential for ensuring stability and suitability of the site prior to construction. During the construction phase of the Upper Tamakoshi Hydropower Project, the 2015 Gorkha Earthquake caused substantial damages, triggering the need for further geotechnical evaluation of the dam site area. The primary objectives at that time were to delineate the bedrock depth on the left and right abutments as well a

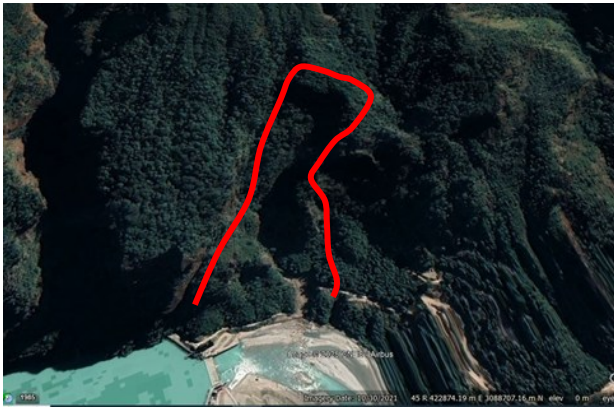
Figure 1, Scarp of paleo-landslide at the left abutment of damsite area.

- Morphological study and visual Surface observation: Identification of paleo-landslide along the left bank of Tamakoshi River around damsite area and observation of evidence of fluvial activities above 20 m uphill side from damsite area.
- Exploratory Drilling and Sampling: Boreholes drilled along the dam axis and abutments to determine overburden thickness, bedrock depth and confirm whether the rock of left abutment is bedrock or huge boulder.
- In-situ: Standard penetration tests (SPT), permeability tests (Constant Head Test-CHT in overburden and Lugeon test in rock mass).

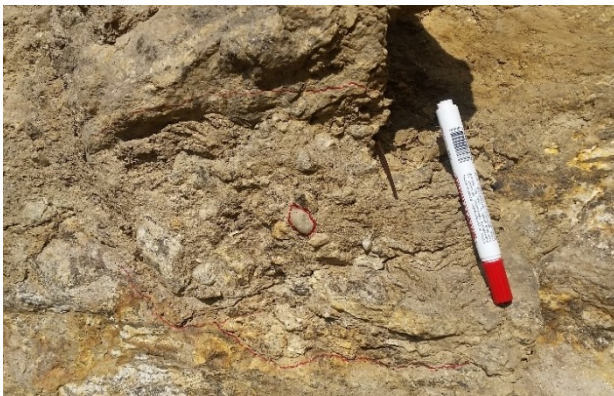
Figure 2, Sub-rounded pebbles present above 20 m uphill side from damsite area.

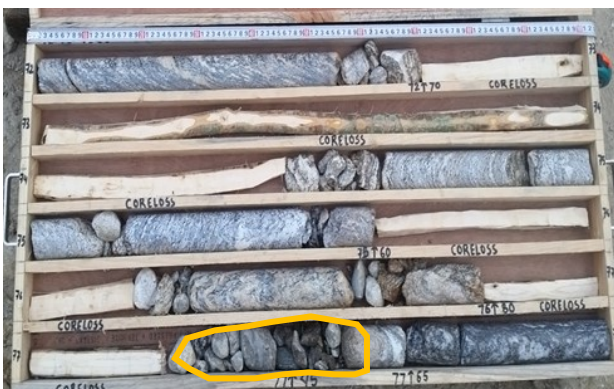
Figure 3, At depth of 77.45 - 77.55 m, angular to rounded pebbles of alluvial deposit (schist, gneiss and granite) is extracted.
