# Engineering Geological Challenges Following the 2024 Noto Earthquake, Japan

**Abstract:** The 2024 Noto Peninsula (Noto-Hanto) earthquake significantly impacted infrastructure and communities in Central Japan, unveiling critical engineering geological challenges. To our knowledge, this paper presents the first systematic field survey conducted eight months after the mainshock, focusing on the post-disaster phenomenon and their recovery states. Through ground visits, satellite imagery analyses, and high-resolution DEM differencing, we identified persistent deep-seated gravitational slope deformation (DGSD) undermining tunnel stability, land uplift, structural collapses from soil liquefaction, and several landslides, with rural areas experiencing severe impacts. Our observations reported that the crustal uplift has permanently altered hydrological regimes and DGSD remains active beneath major tunnels, inducing tunnels spalling. Slope failures have progressed under cumulative rainfall loading, and tunnel linings show evolving structural distress linked to both DGSD and residual seismic damage. Lateral spreading, ground upheaval, ground settlement, sinking of utility poles, and the

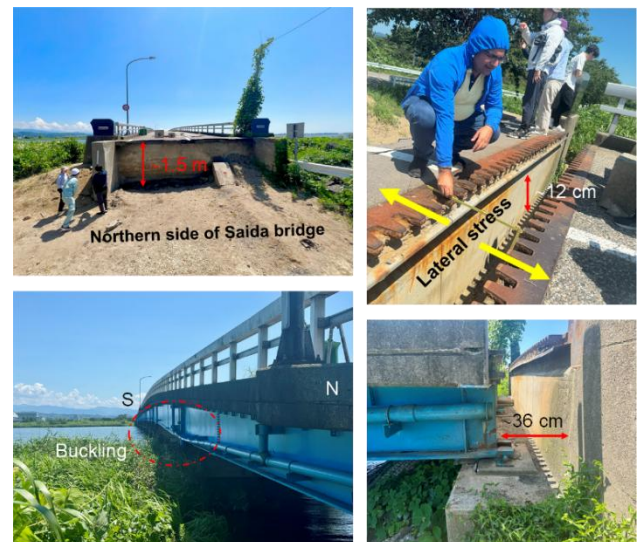
In Uchinada Town, the Saida Bridge has collapsed due to ground subsidence, disrupting the connection between the structure and the ground (Figure 3). The area, a floodplain located at the neck of Kahokugata Lagoon, has experienced significant subsidence due to sand liquefaction. Traffic on this bridge has been completely

halted since the event. Lateral stress caused the bridge's northern side to pop up, displacing the abutment with a 36 cm lateral crack toward the south and a vertical movement of 12 cm, leading to the buckling of the bridge's middle section, which remains visible today. Figure 4 further illustrates liquefaction-induced engineering geological issues. Mizuno et al. (2024) reported the damage to the twin bridges (Naka-Noto Agriculture Bridge and Noto Island Ohashi Bridge) that connect Noto Island and the Peninsula. Additionally, a two-day emergency survey conducted using a microtremor array revealed ground shaking lasting approximately 4–5 minutes, which resulted in several liquefaction-induced damages in Uchinada Town. These included lateral spreading over approximately 2.7 hectares, ground upheaval, ground settlement, lateral displacement in the northwest to southwest direction, sinking of utility poles, and the presence of sand ejecta.

*Figure 3, Damages in the Saida Bridge, Uchinada (Bridge offset vertically over tens of centimeters) (date of photographs taken: August 3, 2024).*

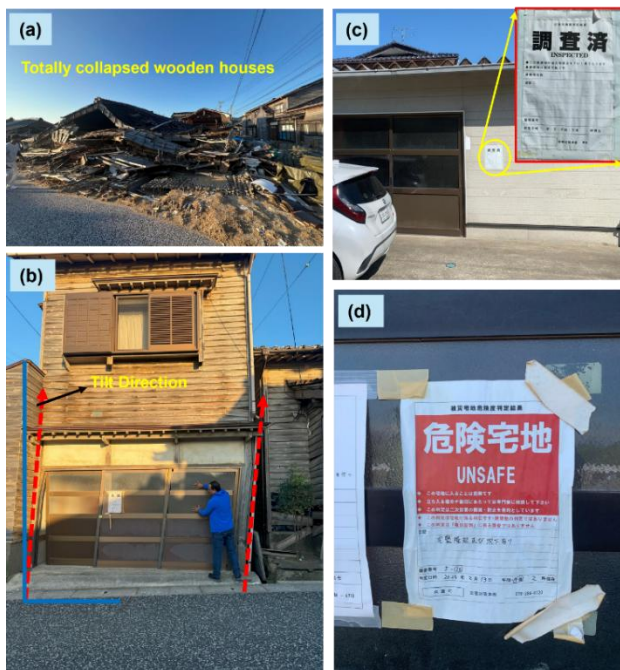
Figure 7, (a) Completely collapsed building along Wajima city; (b) tilted building; (c) building inspection certificate; and (d) inspection certificate attached to a building suffered with uplift and subsidence (date of photographs taken: August 3, 2024).

remain untouched, and critical infrastructure repairs are yet to progress significantly. Among completely or partially damaged houses, yet many remain standing without being demolished, and as of May 26, only 2% have been demolished and removed (Ishikawa Noto Earthquake Interim Report 2024). Demolition requires specialized skills, but the number of qualified contractors is limited. The reason the demolition process is taking so long is the lack of a number of qualified contractors and adequate worker accommodation. The quake-hit area is still full of rubble, which might be due to delays in damage assessment surveys by the local government. Many tilted houses are still in danger of collapsing. The condition of the houses has been inspected, and inspection certificates are attached to the outer walls to inform residents of their condition (as depicted in Fig. 7).

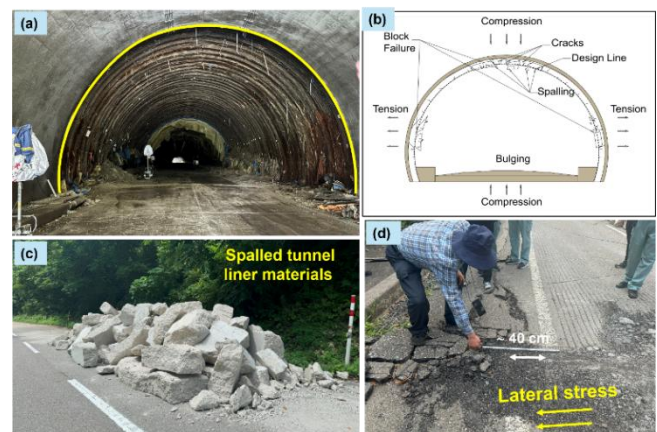
After the earthquake, the landslide in the Utsuyama area impacted on the stability of the Otani tunnel, leading to the tunnel liner spalling (Figure 8). The spalled lining materials have been mocked out of the tunnel and kept on the roadside. The landslide caused the ground to slip laterally around 40 cm on the road and the Otani loop bridge (Figure 8d).

Figure 8, (a) Otani tunnel damaged by the sliding mass; (b) schematic diagram of liner spalling; (c) concrete liner mocked out from the tunnel; and (d) lateral slip observed along the roadside near the tunnel entrance (date of photographs taken: August 4, 2024).

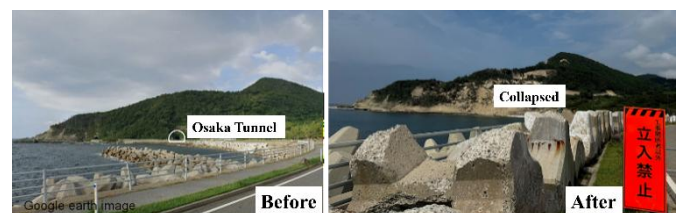
The route between Suzu City and Otani-Cho remains closed due to the tunnel collapse, even eight months after the disaster. Similarly, the Osaka Tunnel on the northwest side of Mauramachi has been entirely covered by landslide debris and slope failure, rendering the tunnel entrance unrecognisable today (Figure 9).

Figure 9, Collapsed Osaka tunnel before and after the 2024 Noto earthquake [date of photograph taken (after): August 4, 2024].
