Stability Assessment of High Cliff Slopes in Carbonate Rocks - A Case Study, Kingdom of Saudi Arabia (KSA)

Abstract: This study evaluates the stability of high cliff slopes along a 1 km long carbonate–volcanic ridge in the Kingdom of Saudi Arabia. Geological mapping, satellite imagery, and over 350 joint measurements were used to characterize rock mass conditions across three zones. Rock mass ratings and direct shear tests provided inputs for kinematic and analytical stability assessments using Rocscience and Slope/W. Results indicate potential planar, wedge, and toppling failures controlled by key joint sets, with global factors of safety of about 1.5 (static) and 1.2 (dynamic). A 1–1.5 m distressed zone was identified along the cliff edge, and Safe Working Line (SWL) distances were recommended considering a 250 kPa surcharge. The study provides essential guidance for safe development near steep rock escarpments.

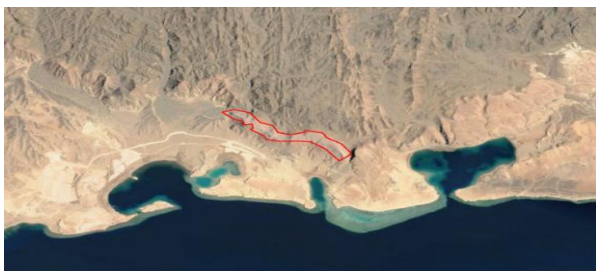
Figure 1, Google image showing project Layout.

The geological mapping of the ridge/ cliff was carried out to characterize and classify the rock mass, besides checking out the stability of the cliff sections. The study area along a ridge of about 1 km in length covering about 450,000 m² area. The site is distinctly marked by the presence of an NNE–SSW trending ridge with cliff face of about 70–100 m in height (Figure 1). The hilltop is 50–100 m wide with sloping surfaces at an angle of 55–70°. Two lineaments trending E–W cut across the hill ranges and divide the ridge into Z1, Z2 and Z3 (Figure 2).

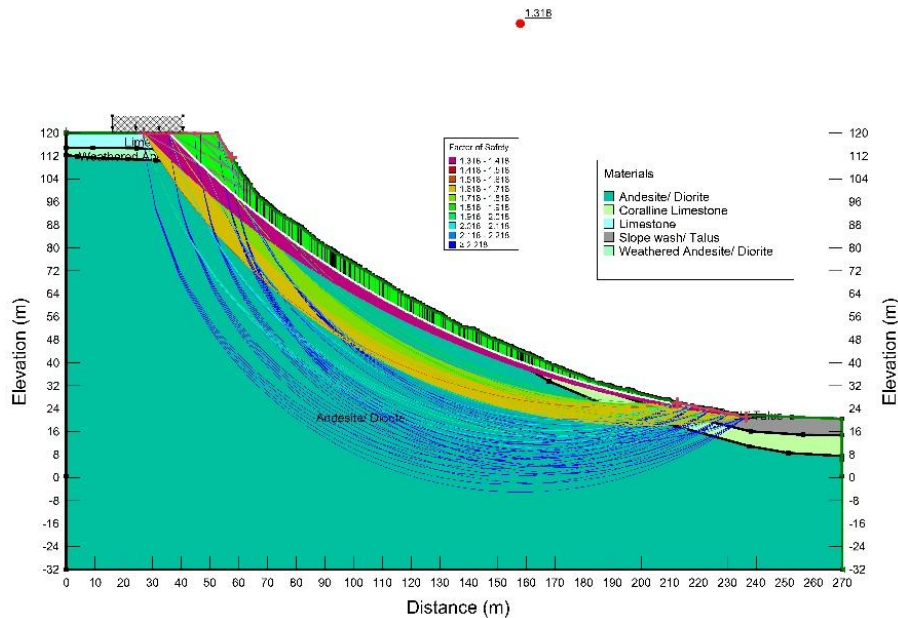
Figure 5, Typical W/Slope analysis outputs- Global outputs of global stability.

Output- Static (FoS 1.522)

Output – Dynamic (FoS 1.318)

Global stability checks, for the existing slopes, were carried out. The results with FOS of 1.5 and 1.2 for static and dynamic conditions were calculated (Figure 5).
