Stability Assessment of High Cliff Slopes in Carbonate Rocks - A Case Study, Kingdom of Saudi Arabia (KSA)

Mohammed Musthafa Khaleel^{1*}, Anas Al Barakat¹, Mohammed J Ahmed¹, Shahid Iqbal¹ and Kurian Jacob¹

¹Arab Centre for Engineering Studies, Dubai, United Arab Emirates

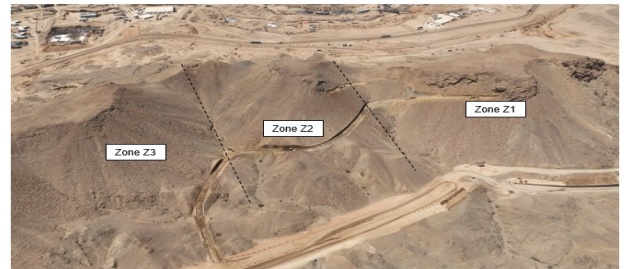
Figure 2, Google image showing zones distribution.

The geological mapping of the ridge/ cliff was carried out to characterize and classify the rock mass, besides checking out the stability of the cliff sections. The study area along a ridge of about 1 km in length covering about 450,000 m² area. The site is distinctly marked by the presence of an NNE–SSW trending ridge with cliff face of about 70–100 m in height (Figure 1). The hilltop is 50–100 m wide with sloping surfaces at an angle of 55–70°. Two lineaments trending E–W cut across the hill ranges and divide the ridge into Z1, Z2 and Z3 (Figure 2).

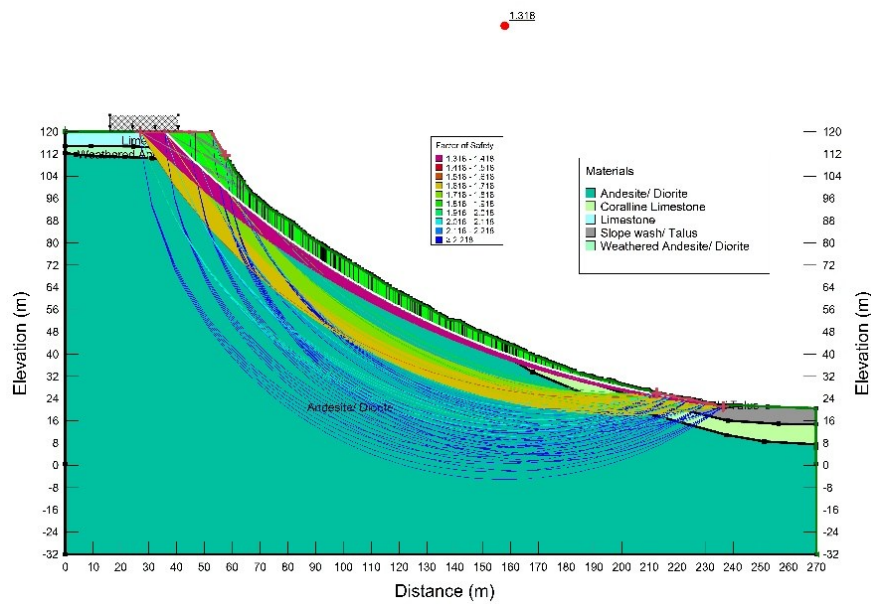
Figure 5, Typical W/Slope analysis outputs- Global outputs of global stability.

Output- Static (FoS 1.522)

Output - Dynamic (FoS 1.318)

Global stability checks, for the existing slopes, were carried out. The results with FOS of 1.5 and 1.2 for static and dynamic conditions were calculated (Figure 5).
