# Erosion and Mass Wasting Processes in Post-Wildfire Mountainous Terrains: Impacts and Challenges

Tümay Kadakci Koca<sup>1\*</sup>

<sup>1</sup>Muğla Sıtkı Koçman University, Geological Engineering Department, Muğla, Turkey

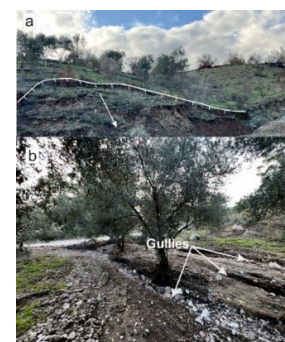
Figure 1, In the aftermath of wildfires a) shallow failures b) gullies filled with debris in the lower catchment.

One of the primary challenges in post-wildfire mountainous environments is the complex and spatially heterogeneous ground response to fire-induced disturbances, especially in relation to vegetation type, soil/rock properties, and burn severity. This variability complicates the prediction of erosion rates and the initiation mechanisms of mass wasting processes, including shallow landslides, debris flows, and rockfalls. The absence of pre-fire baseline data further complicates efforts to isolate fire-induced impacts from natural background variability. Although remote sensing tools offer wide spatial coverage, they often fail to capture near-surface mechanical weaknesses in real time. Additionally, even low-severity or unburned downslope areas are affected by intense gully erosion and shallow failures due to runoff from severely burned upper slopes in the catchment (Figure 1).
