Tunnel Stabilization: A Case Study of Effective Grouting and Support Measures in Upper Sanigad Hydroelectric Project, Bajhang, Nepal

Abstract: This case study presents a comprehensive overview of the small size tunnel stabilization and excavation efforts undertaken in the Upper Sanigad Hydroelectric Project (USHEP), located in the Kalanga Basin, Bajhang, Nepal. The project site is situated in the Lesser Himalaya geological unit, Galyang Formation of Midland group, by complex geology comprising meta-sedimentary and carbonate rocks. The tunnel excavation faced significant ground stability challenges due to the weak and fractured nature of the rock masses, high tectonic stress, and significant water pressure.

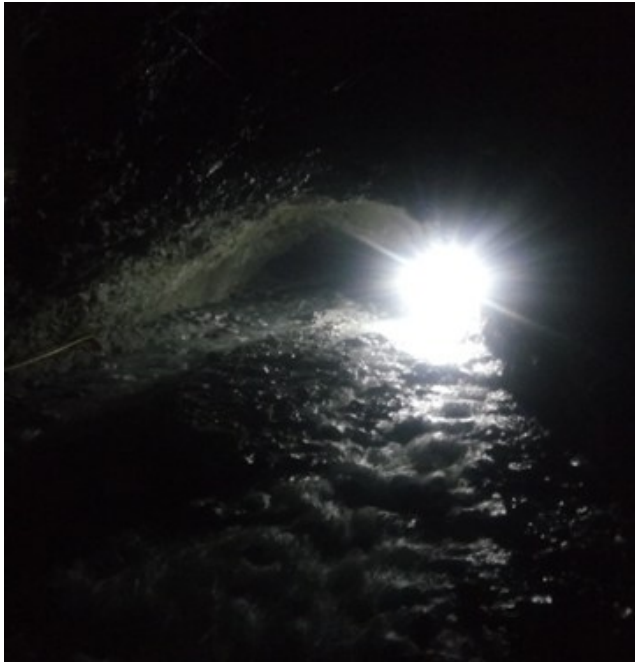
Initially, the rock mass was classified as fair to poor, characterized by thin to medium-bedded fractured dolomite, multiple shear bands filled with 2–4 cm thick clay, and three + random joint sets with moderate water inflow. Based on the assessed Q-value, rib supports were installed at 1 to 1.5-meter intervals in accordance with the approved design. A sudden cavity outburst occurred after the installation of the third rib set, during drilling for forepoling. Although there were no human casualties, the muck loader, Shotcrete machine, and jackhammer were buried under the debris.

Figure 2, Debris Flow after over bursting Cavity.

The operation began with the gradual removal of debris and the extraction of buried equipment, including a muck loader, shotcrete machine, and other machinery.

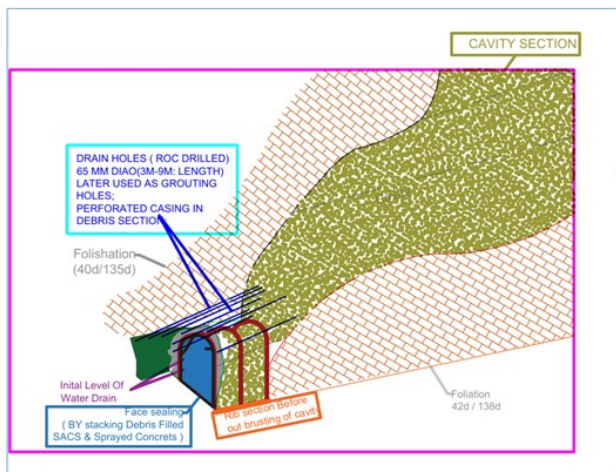
Cavity treatment was carried out in a systematic sequence including debris removal, extraction of buried equipment, face sealing, drilling of drainage holes, grouting, heading and benching excavation and implementation of support measures (Figure 2 and 3).

The grouting concept aimed to allow heavier grout particles to settle within the water-saturated debris, gradually raising the water level inside the semi-enclosed cavity chamber. This process enabled controlled water inflow through already drilled holes at higher elevations. Once initiated, the operation proceeded smoothly, and the approach proved effective. The loose zone was successfully stabilized after the second stage of grouting.

Figure 3, Schematic diagram of cavity and Treatment approach.

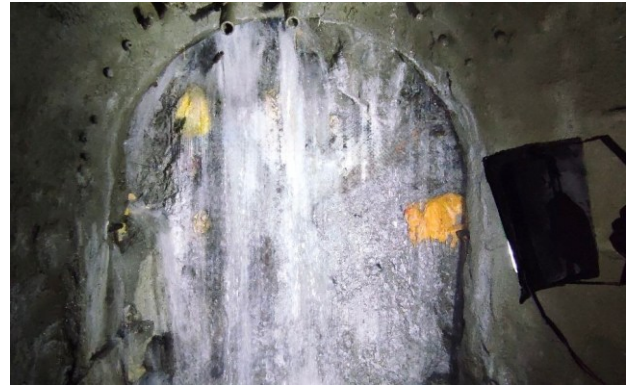
Figure 4, After Sealing of Face.

The next objective was to seal the tunnel face near the cavity section. This sealing was carried out at the first rib, which had been installed prior to the cavity outburst. The process involved:

- Stacking debris-filled sacks
- Fixing crossed rebar of 25 mm dia. and steel channels
- Applying sprayed concrete

Water ingress was allowed to escape from one side of the sealed face to relieve pressure.

Sealing the tunnel face near the cavity was one of the most challenging tasks. As an immediate measure, debris-filled sacks were stacked promptly while maintaining the slope of the face. This temporary wall of sacks acted as a permeable barrier, allowing water to filter through and thereby relieving pressure within the cavity.

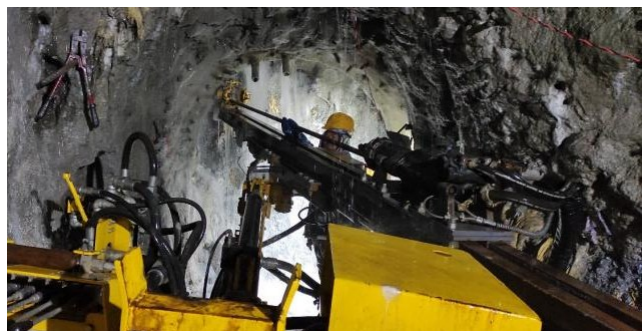
The subsequent step is drilling holes to release water from the cavity and to inject grout into the semi-enclosed chamber. A total of 20 holes were drilled, ranging in length from 3 to 9 meters and with a diameter of 65 mm. These were positioned at various levels and back Chainage from the sealed face. The connection to the cavity chamber was confirmed by encountering loose debris zones and observing water discharge from some of the holes.

Figure 5, Drilling of Drain holes by ROC.

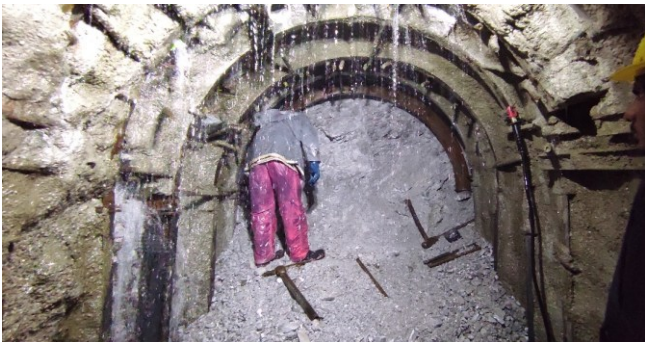
Figure 6, Heading and Benching -Excavation after Grouting.

Following the successful grout injection and adequate curing time, the next phase involved excavation using the heading and benching method. Excavation was carried out with a pneumatic breaker. Initially, two sets of crown ribs were carefully installed at intervals of 0.3 to 0.5 meters. Subsequently, the bench portion was removed, allowing for the installation of the rib legs.

Forepolings were also implemented above the spring level, using 3.5 M long rebar of 25 mm dia, spaced at 150-200 mm intervals.

Afterward, the second stage of grouting commenced in a similar manner, with a total of 251 bags of cement injected. Excavation continued using the heading and benching method, accompanied by the installation of support structures.

In total, 50 sets of steel ribs were installed- 0.3 to 0.5 M spacing in the major cavity section and 1.0 to 1.2 M in adjacent section the cavity section was successfully stabilized over a period of three and a half months.

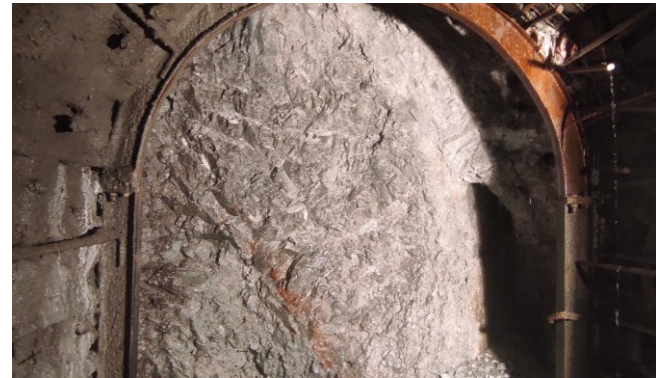
Figure 7, Rock Mass after Major cavity zone.
