# Low-Cost Landslide Mitigation Measures for Roadside Slopes: A Case Study of Jamunedanda, Pyuthan, Nepal

**Abstract:** Roadside landslides are a recurrent problem along mountain highways in Nepal, where weak geological materials, steep terrain, rainfall infiltration and concentrated runoff can interact to reduce slope stability. This paper presents a field-based case study of the Jamunedanda landslide at Ch. 27+800 of the Bhaluwang–Chakchake–Liwang–Darebot Road (NH-53), Pyuthan, Nepal. The investigation combined desk study, topographic survey, engineering-geological mapping, field geotechnical testing, laboratory testing, infiltration assessment and numerical slope-stability analysis. The site is characterized by highly weathered and fragmented black shale with colluvial and gravelly slope materials, erosional gullies, tension cracks and tilted trees. Laboratory results showed natural moisture contents of 4.88–14.88%, specific gravity of 2.64–2.74 and bulk density of 1.51–2.00 g/cm<sup>3</sup>, while grain-size analysis indicated predominantly SP, SW and GP-type materials. Preliminary PLAXIS 2D analysis indicated marginal natural-condition stability. The mitigation concept combin

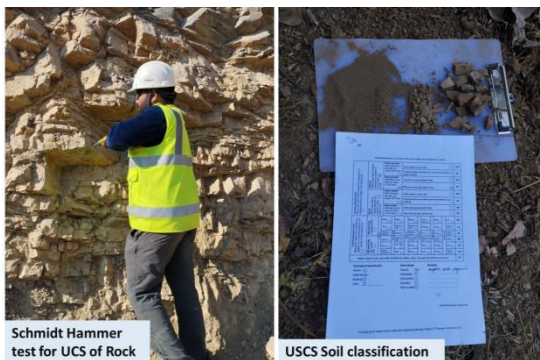
Figure 2, Field investigation activities including Schmidt hammer testing and in-situ USCS soil classification.

Engineering-geological mapping at approximately 1:1000 scale documented lithology, weathering, discontinuities, cracks, gullies, drainage features, springs, old landslide masses and other geomorphic indicators. More than 200 discontinuity measurements were collected at representative rock exposures for rock-mass characterization and kinematic assessment. Field tests included USCS soil classification, relative-density assessment, Schmidt hammer testing and infiltration testing by the inverse-borehole method.

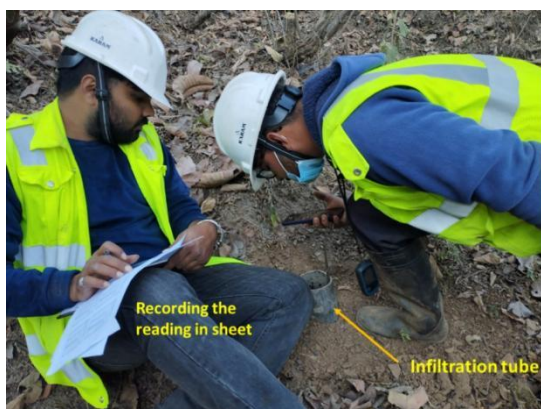
Figure 3, Infiltration assessment at Jamunedanda using the inverse-borehole method.

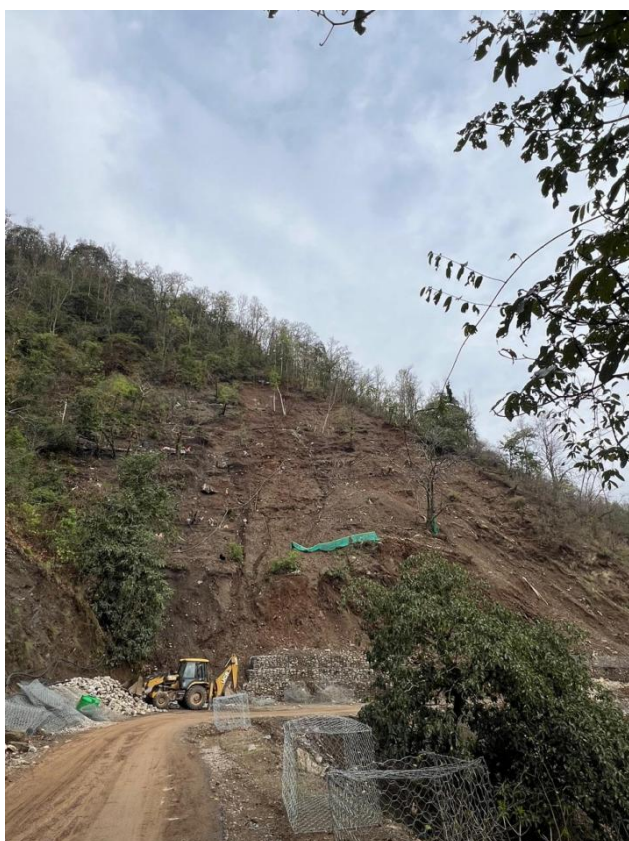
*Figure 5, Jamunedanda slope before/during construction.*

Bioengineering was implemented over the upper and middle slope to provide surface erosion control and progressive vegetative stabilization. Locally available species including Napier, Simali, Bhujiro and Asuro, together with other suitable vegetation, were established on the treated slope. The before/during and post-construction photographs show the change from an exposed, partly treated slope with active construction works to a stabilized slope with anchor heads, gabion structures and developing vegetation.

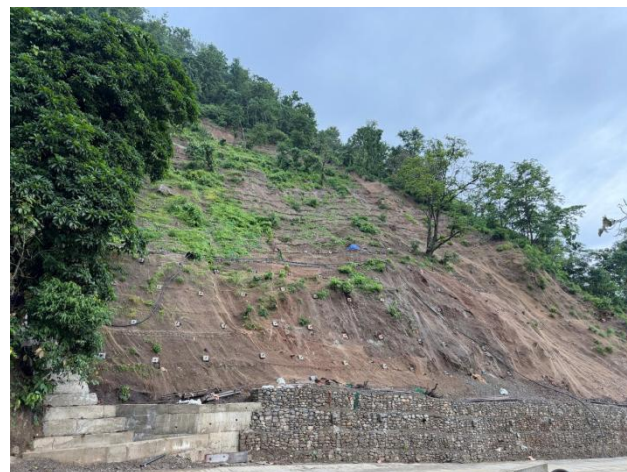
*Figure 6, Jamunedanda slope after construction and completion of the mitigation works.*
