# Rasuwa 2026 Flood Disaster: Field Experience, Rescue Challenges, and Lessons Learned from Upper Trishuli 3A and Chilime Hydropower Projects

Uday Raj Neupane<sup>1\*</sup>

<sup>1</sup>Clay Engineering and Research Center Pvt. Ltd., Kathmandu, Nepal

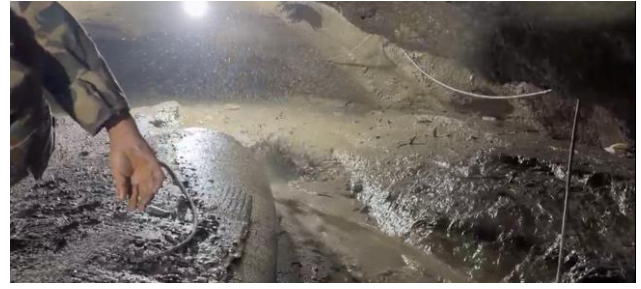
Figure 2, Water management and hydraulic debris-clearing works at Chilime

drawings were reviewed to identify a technically feasible and comparatively safe rescue alignment. A clear-water source was identified at approximately 220 m chainage, with water collected and pumped from a lower chainage. A measured discharge of approximately 1.66 L/s was observed, allowing gravity drainage and reducing hydraulic pressure in the affected area. Field observations indicated predominantly fine-grained debris, including approximately 10–15% clay, 60–70% silt, and 10–20% sand, with other material fractions after the chainage of 90m but before that materials with large boulders were found and cleared by manually and excavator, loader etc. This fine-grained and saturated material significantly restricted mechanical excavation and prolonged clearing.

Based on these observations, a water-jet-assisted debris-removal approach was adopted. Water was directed into the obstructed material to loosen and mobilize fine-grained debris; while pumping and manual clearing were used to establish a safe passage. The field record indicates that two water jets achieved breakthrough after approximately 36 hours, demonstrating the potential effectiveness of hydraulic methods where conventional mechanical excavation is severely constrained by confined conditions and fine-grained saturated debris. No survivors were found. Five bodies were recovered out of the six missing persons, while one person remains unaccounted for.
