Engineering Geological Study and Slope Stability Analysis along the Kanti-Rajpath from Chun Danda to the Simat Khola, Central Nepal

Abstract: Stability analysis of the cut slope of a road section is necessary to prevent damage to the road and the surrounding environment. The study encompasses engineering geological assessment, the cut and fill slope failure analysis of the road section of the Kanti-Rajpath from Chun Danda to the Simat Khola, Makwanpur. Four different cut and downslope critical slopes were selected to represent the overall road section for stability modeling. Four slopes were chosen based on high cut-angle, lithology and visible slope instability to represent the range of conditions along the alignment. The maximum 1-day monsoon rainfall data was used for seepage modeling using the FEM-based software SEEP/W and stability analysis to calculate the Factor of Safety (FOS) using SLOPE/W software of GeoStudio package. The results indicate that the slope appears to be marginally stable to unstable under the given rainfall condition. Our results indicate FOS values of 0.78–1.9, underscoring the need for drainage and slope-angle control. Approximately 7 km of the 20 km roa

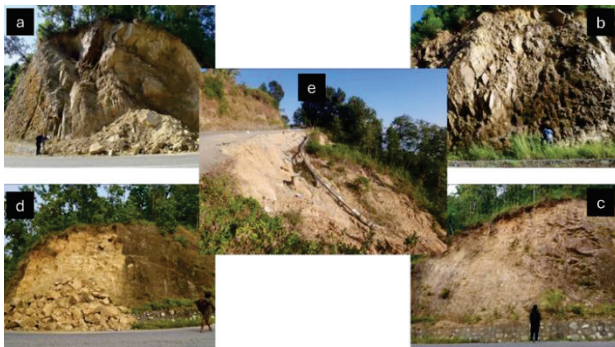
Figure 1, Representative slope conditions along the selected road section; a) Rockfall at Jitpur Bhanjyan, b) Joint sets at Taplakhar, c) Slope condition at Shikhar Kateri, d) Rock fall at Shikhar Kateri and e) Down slope failure at Bar Bhanjyan.

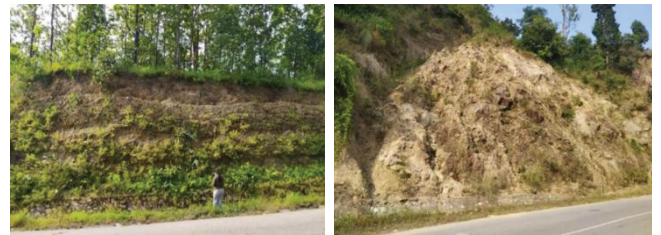
Figure 5, Slope SS1.

Figure 6, Slope SS2.

To represent the range of conditions along the road (Figure 4), four representative cut and downslope soil slopes (SS1–SS4: Figure 5, Figure 6, Figure 7, Figure 8) were selected based on slope angle, lithology and visible slope instability and spatial coverage.

Slope material of SS1 (cut slope) and SS3 (down slope) consist of clay to very fine sand, representing moderately weathered Lower and Lower Middle Siwalik slopes. SS2 (cut slope) and SS4 (down slope) comprise sandy sediments, representing highly weathered Lower Middle Siwalik slopes with “pepper and salt” texture (Table 3).

Slope ID	Location	Slope Type	Height (m)	Soil Type
SS1	Chundanda	Cut slope	10–15	Clay to very fine sand
SS2	Gadhi Bazaar	Cut slope	25	Sandy sediments
SS3	Bar Bhanjyan	Downslope	32	Clay to very fine sand
SS4	Gadhi Bazaar	Downslope	70	Sandy sediments

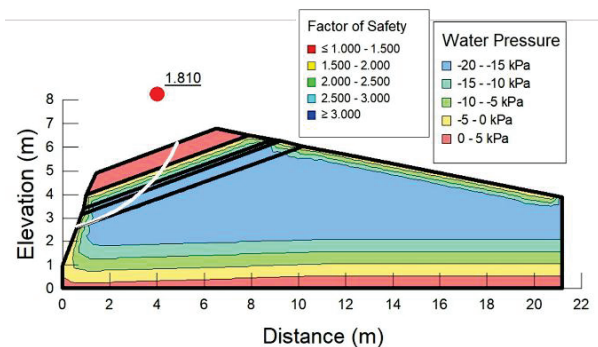
Figure 10, Stability analysis of SS1.

The maximum 1-day annual monsoon rainfall of Makwanpur Gadhi station (2010-2020) was modeled in the simulation. The monsoon rainfall event of 1 day maximum was divided into 240 steps of 6-minute intensity and seepage into the soil was simulated using SEEP/W, GeoStudio. FEM-based transient seepage and stability modeling of four representative slopes under 1-day maximum rainfall showed FOS ranging from 0.78 to 1.946. Small cut slopes like SS1 (Chun Danda) were

stable (FOS = 1.8), while steep cut slopes and tall downslope failures like SS2 (Gadhi Bazaar, FOS = 0.814) and SS4 (Gadhi Bazaar, FOS = 0.78) were unstable. Maximum pore pressures ranged from 2.03 to 5.39 kPa. The slope profiles with their stability analysis results are shown in Figure 10, Figure 11, Figure 12 and Figure 13.

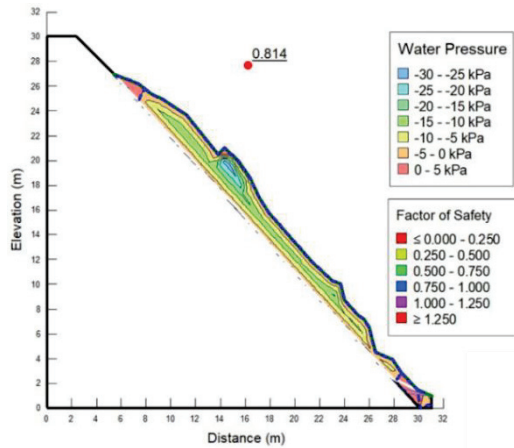
Figure 11, Stability analysis of SS2.

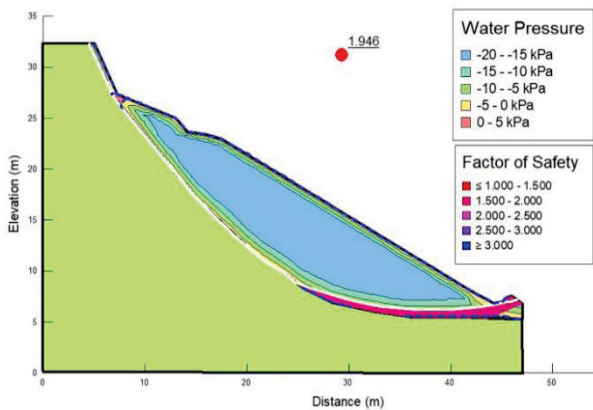
Figure 12, Stability analysis of SS3.
