# Post-Earthquake Unstable Sediment Hazards in Mountain Watersheds: Case Study from the 2024 M<sub>L</sub> 7.2 Hualien Earthquake, Taiwan

**Abstract:** On 3 April 2024, an M<sub>L</sub> 7.2 earthquake struck eastern Taiwan, triggering 18.2 ha of new landslides in the DF174 watershed (292 ha). Roughly 270,000 m<sup>3</sup> of unstable sediment stored on upstream. Loose slope material transformed into debris flows that endangered downstream villages and the culvert bridge. This study integrated field surveys with remote sensing: SAR-based change detection and InSAR track sub-centimeter slope deformation, while repeating UAV survey. UAV-derived DTM differencing indicates ~188,000 m<sup>3</sup> (~70%) of the unstable sediment was deposited downstream, causing channel aggradation, overflow and confluence siltation. Using RAMMS, debris flow simulations under design rainfall scenario show that the 50-year event would rapidly aggrade the riverbed, inundate the culvert, bury the bridge, and potentially block the mainstream—posing extreme threats to downstream school. Mitigation scenarios suggest that lowering the spillway crest of the check dam and constructing additional dams substantiall

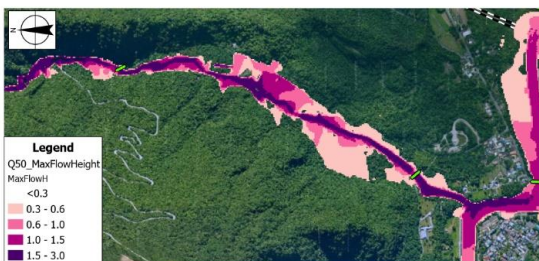
Figure 3, Max flow height during debris flow simulation in Q50 scenario.

In view of the high mobility of the unstable sediment in the Sanzhan watershed. RAMMS (2024): Debris Flows are conducted to quantify potential debris flow impacts. Under design rainfall scenarios, the 50-year event simulation predicts rapid aggradation that inundates the undersized culvert, buries the bridge, and blocks the main stem (Figure 3).

Extreme scenarios further indicate that debris flow could threaten Sanzhan Elementary School. In the mitigation scenarios, lowering the check dam's spillway

crest and constructing additional check dam could substantially reduce debris flow risk and the culvert bridge can be preserved.
